**Re: Rice Drilling D, LLC
NSPS Subpart OOOOa Annual Report**

Rice Drilling D, LLC
NSPS Subpart OOOOa Annual Report

Big Dawg 1HA, 3HA, 5H, 7H Leaking Components Report

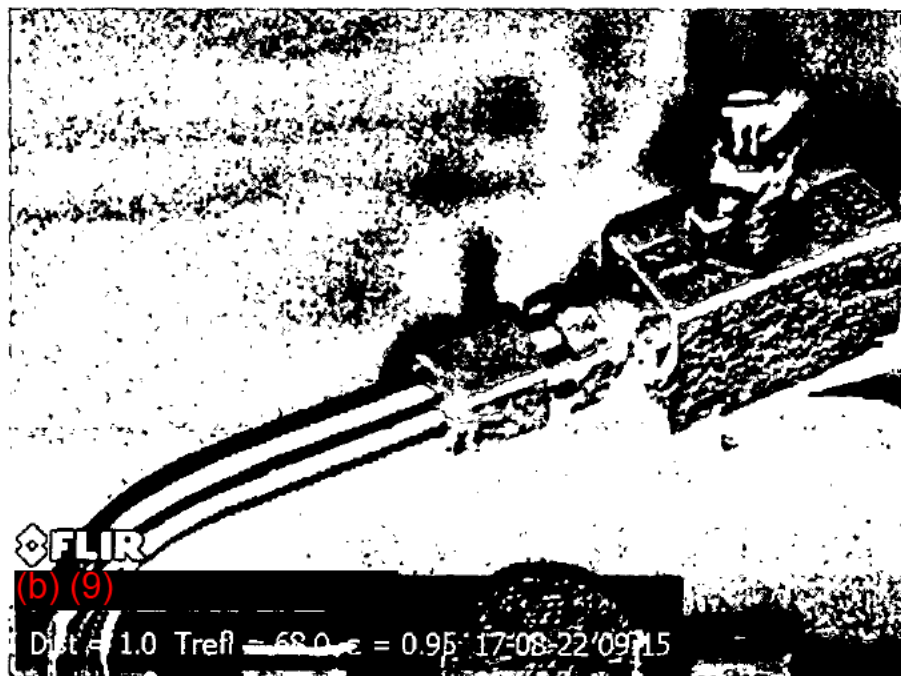
DRAW-20170822-006IR Repaired

Location: 1H GPU Run 1 Stainless Fitting
